CAS CLINIQUE 1

Une femme âgée de 40 ans s'est présentée aux urgences pour une douleur atroce au niveau de la cheville suite a une torsion brutale.

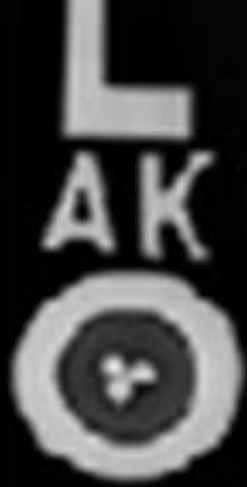
Medial Malleolus Fracture

4.30mm

Medial Clear Space

7.10mm

Tio-fib Clear Space:
Normal < 5mm

fx de la malléole interne avec élargissement
de la syndesmose antérieure.

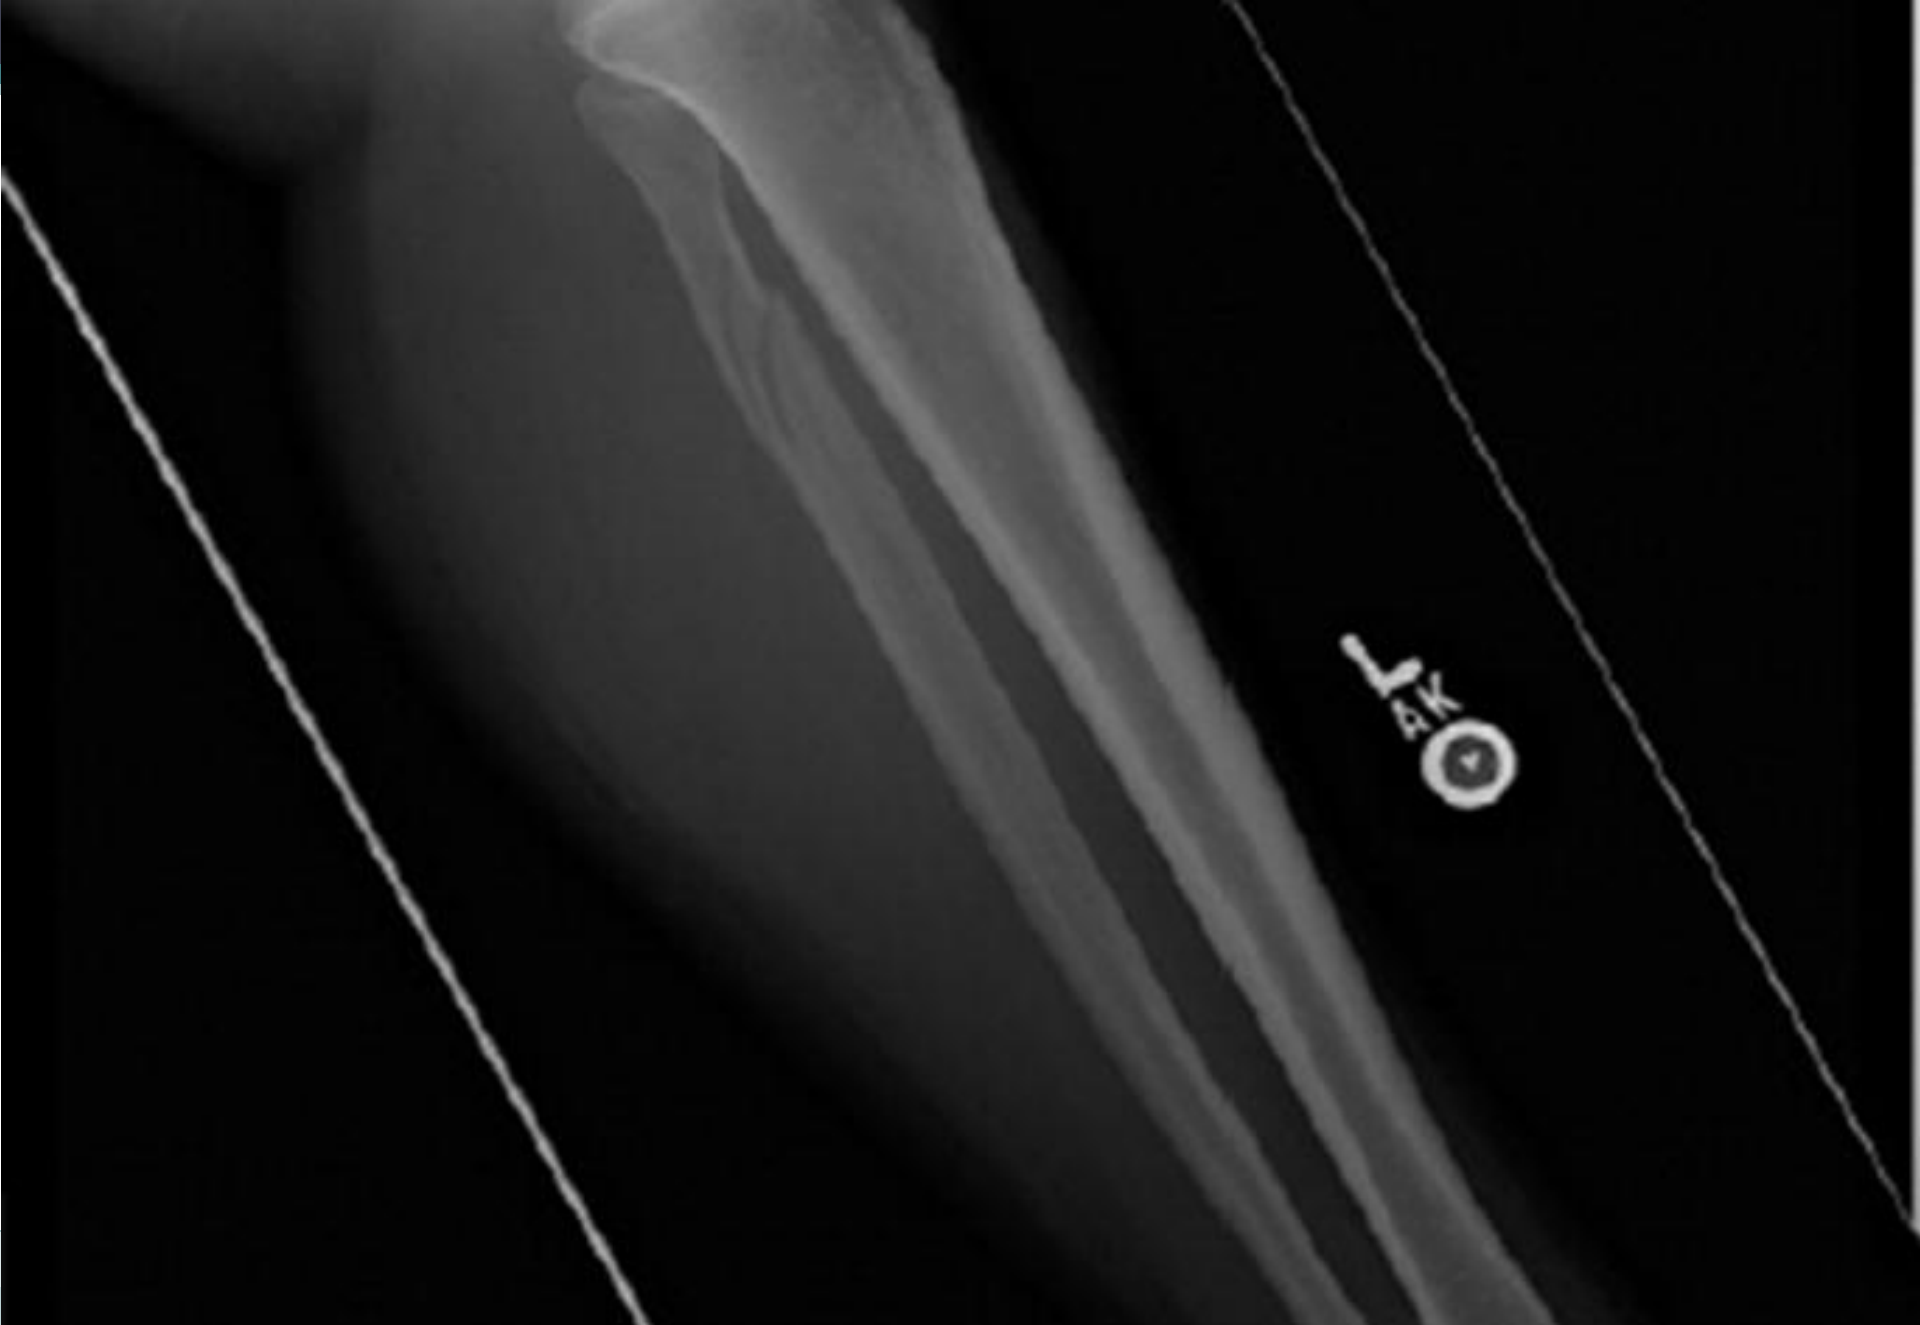
fx en spirale de la partie proximale de la fibula.

- La fracture de Maisonneuve est une fracture instable de la cheville. Elle s'agit d'une association d'une fracture de la partie proximale de la fibula et d'une lésion de la malléole interne ,du ligament deltoïde ou de la syndesmose tibio-fibulaire. Elle est causée par une éversion de la cheville.
- En cas de lésion de la malléole interne , la partie proximale de la fibula devrait être toujours examinée .
- Il s'agit d'une lésion instable qui nécessite dans la majorité des cas une réduction a ciel ouvert et une fixation interne.

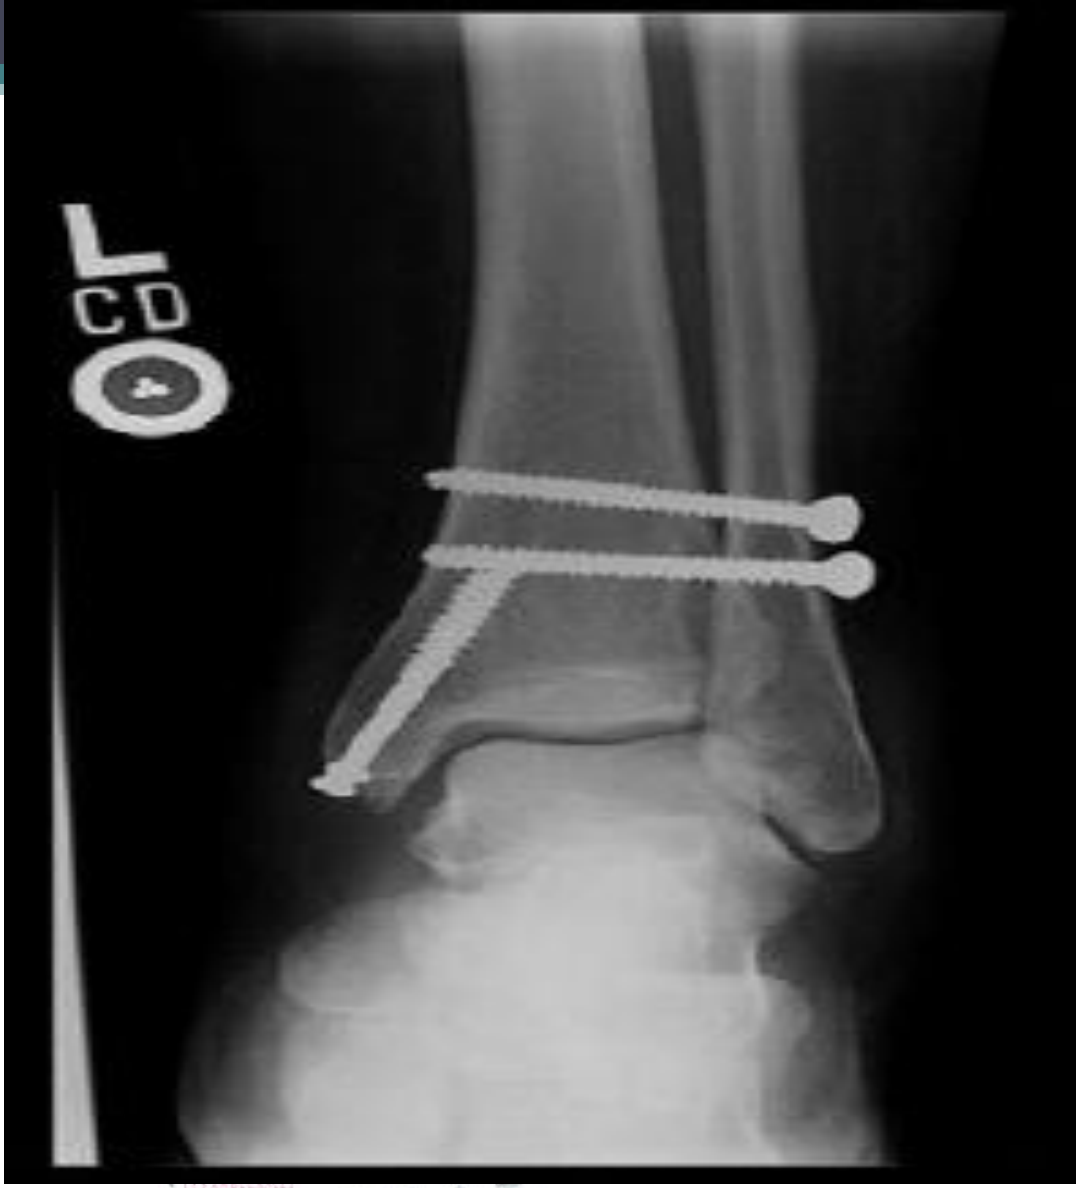
Rx post réduction et fixation interne.
